Naval Command.
Control and Ocean
Surveillance Center

Evaluation of Nondestructive Inspection Techniques for Quality Control of Alumina-Ceramic Housing Components

Technical Report 1588
September 1993

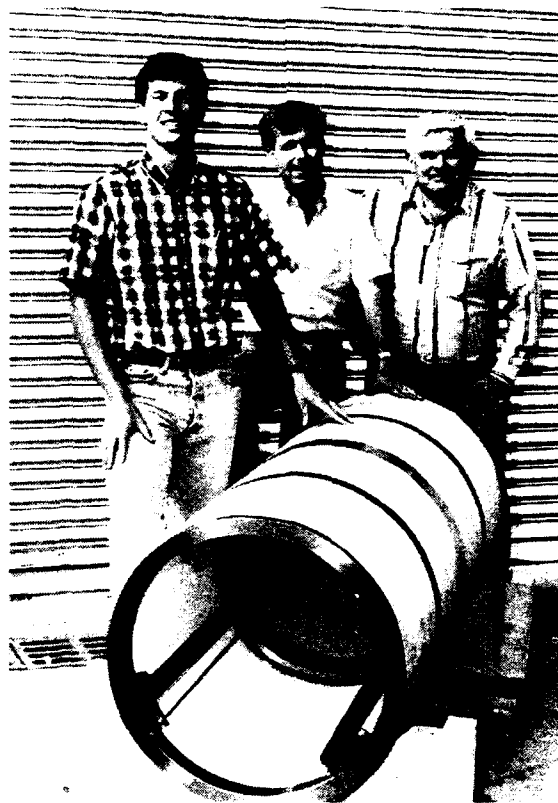
Figure 2. Photo of cylindrical hull section of 25-inch-diameter alumina-ceramic housing.

A typical deep submergence housing as designed at the Naval Command, Control and Ocean Surveillance Center (NCCOSC) RDT&E Division (NRaD) is shown in figures 1 and 2.* This housing consists of alumina-ceramic cylinders and hemispheres joined to each other by metallic end rings, typically machined from titanium or aluminum. The metallic end rings are epoxy-bonded to the ceramic components. Design details on typical NRaD designed housings may be found in references 2 and 3.

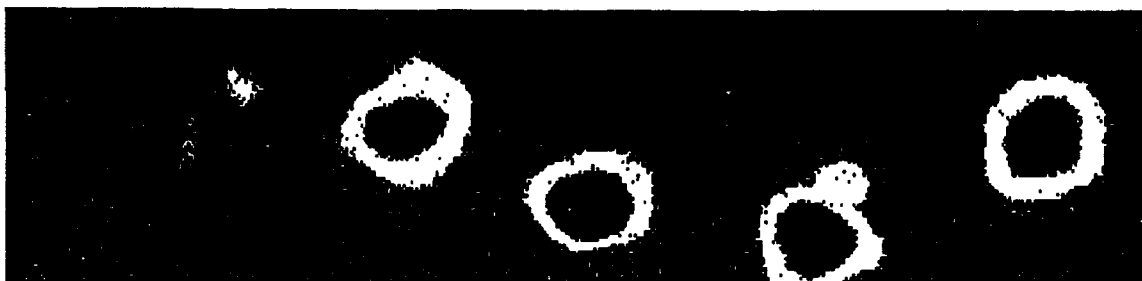
Figure 60. C-scan obtained by SAM of one column of defects found in as-fired curved ceramic specimen (G2) containing 0.105-inch-square by 0.005-inch-thick planar defects. The area shown represents a 0.5-inch by 2.25-inch area on the specimen.

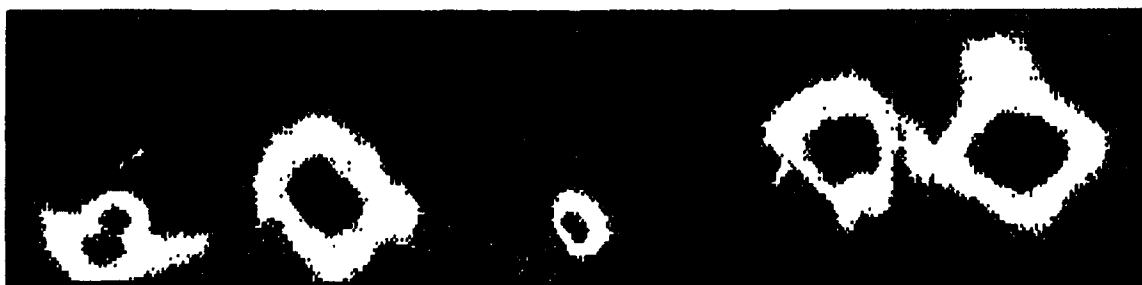
Figure 61. C-scan obtained by SAM of one column of defects found in as-fired curved ceramic specimen (H2) containing 0.210-inch-square by 0.005-inch-thick planar defects. The area shown represents a 0.5-inch by 2.25-inch area on the specimen.
